Identification of Grouting Discontinuity of Rock Bolts as an Efficient Way to Control Safety Conditions in Mine Roadways

A. Staniek

Central Mining Institute, POL

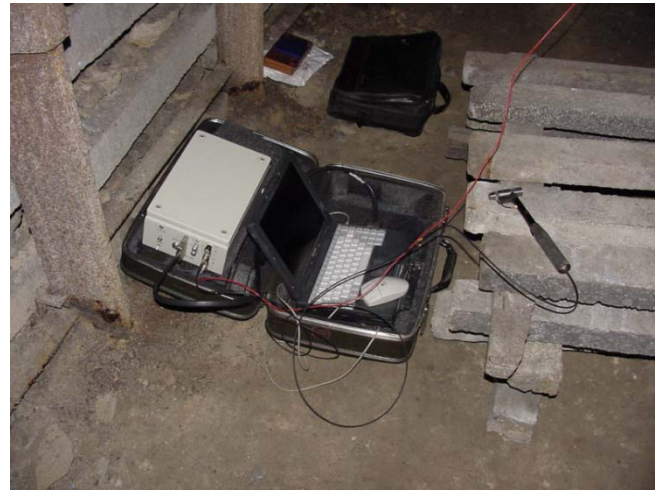
FIG. 2 a: PORTABLE UNIT FOR ACQUISITION AND RECORDING OF FREQUENCY RESPONSE FUNCTION, IN SITU MEASUREMENT

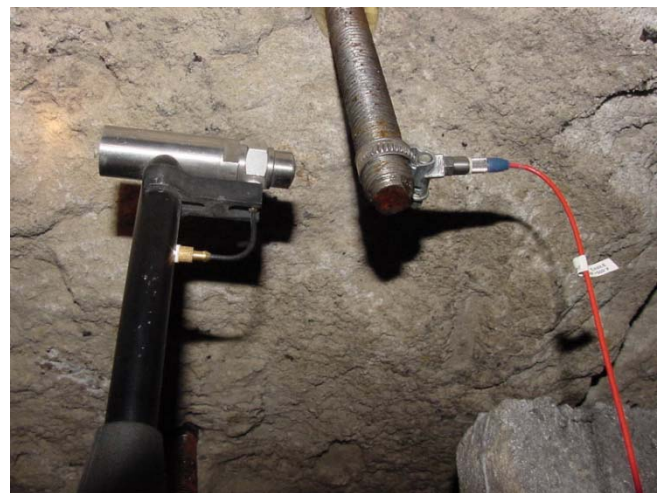
FIG. 2 b: EXCITING A ROCK BOLT WITH AN IMPACT HAMMER, RESPONSE OF THE IMPACT MEASURED WITH PIEZOELECTRIC ACCELEROMETER
